Bournemouth University

Heat Decarbonisation Plan

Full Plan

March2023

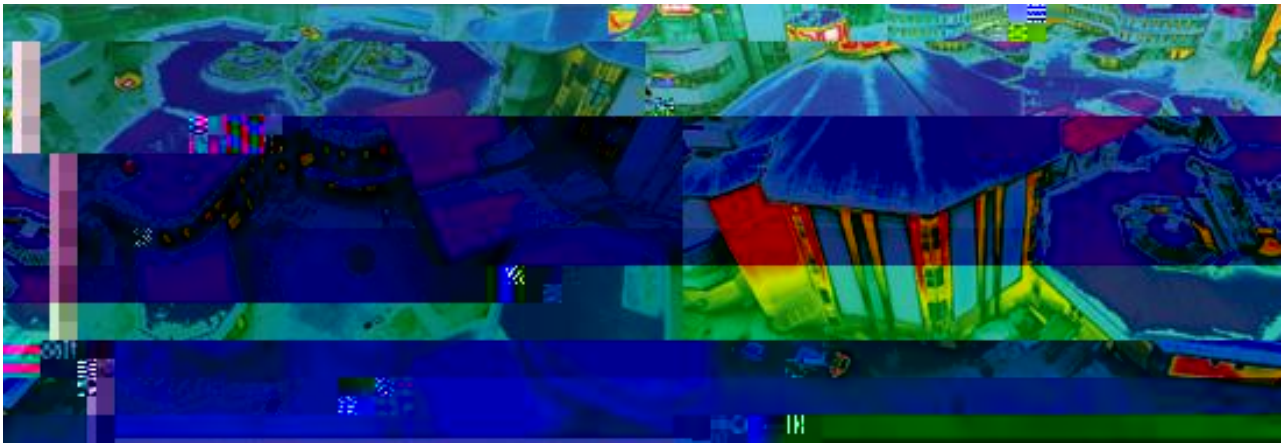
Talbot Campus - SMCL

- The roof appears to be in good condition, with a uniform temperature observed
- The biggest concern with this building is the glazing on the original construction. These appear to have varying levels of performance with some showing temperatures of ~15degC indicating poor installation or air leakage
- On all elevations, there is evidence of a thermal leak between the roof joins including the crown on top of the tower

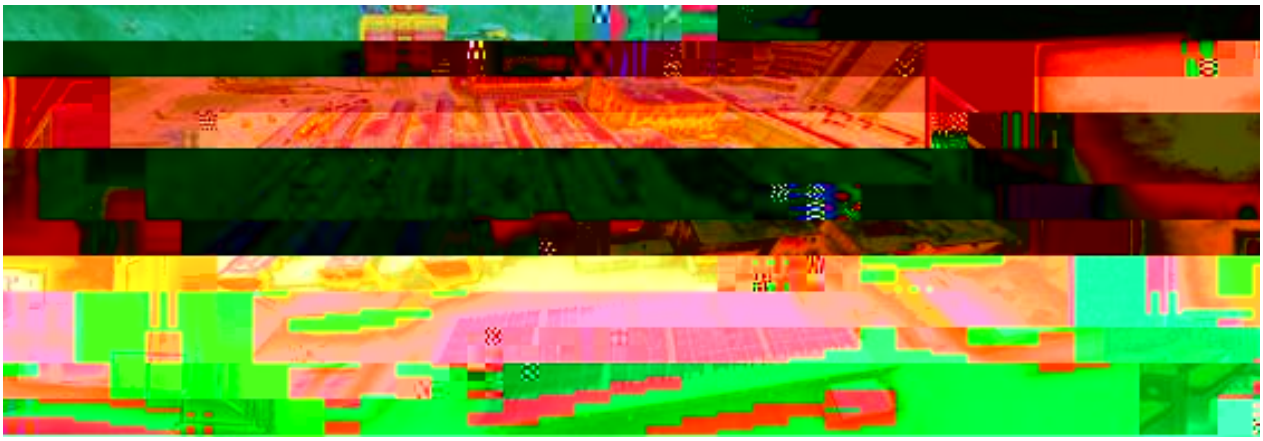
Talbot Campus - Poole House

- The roof appears to be in good condition, with a uniform temperature observed
- The southern elevation (by the Estates Reception) appears to either be missing insulation, or installed insulation has degraded significantly
- The glazing across this building is mixed, with some performing as expected and others performing very poorly

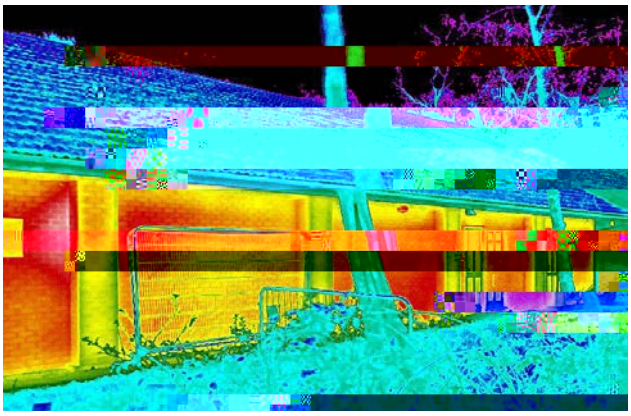
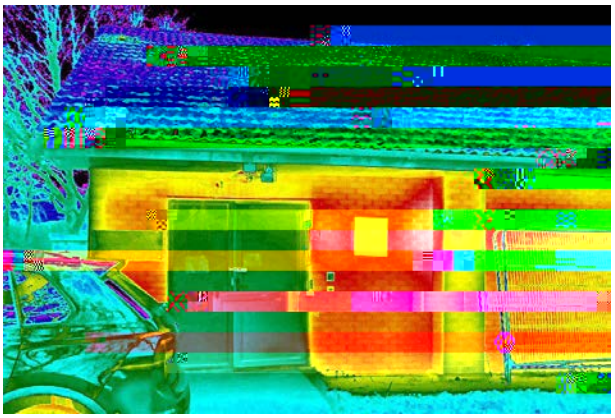
Chapel Gate - Tennis Club

- There are good even temperatures across some of the elevations suggesting that the insulation is performing well
- Minor areas of heat loss noted at the roof line.
- The temperature across the south elevation appears high further investigation is recommended in this area to ascertain insulation levels or other factors

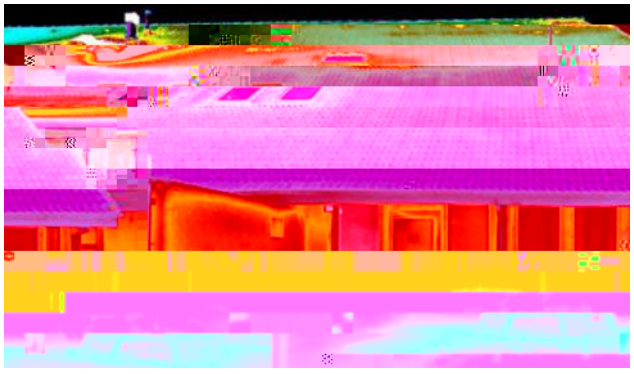
Chapel Gate² Sports Campus

- Overall, the roof and elevations show an even colour and temperature distribution, suggesting very little heat loss
- The windows, and especially their frames, are operating very poorly which indicating aging assets or poor installation not prioritising thermal performance
- The red vented areas should be investigated further for missing or misaligned insulation
- Insulation is performing poorly on both walls of the south elevation, it appears to have little or no insulation
- The door appears to be performing poorly, this should be investigated further as it was in constant use at the time of the survey
